Little Shoal Bay Coastal Processes Issues and Options Assessment

REPORT PREPARED FOR AUCKLAND COUNCIL

Date: 21/07/2020
Reference:3-AWD50.00
Status: Rev 3 DRAFT

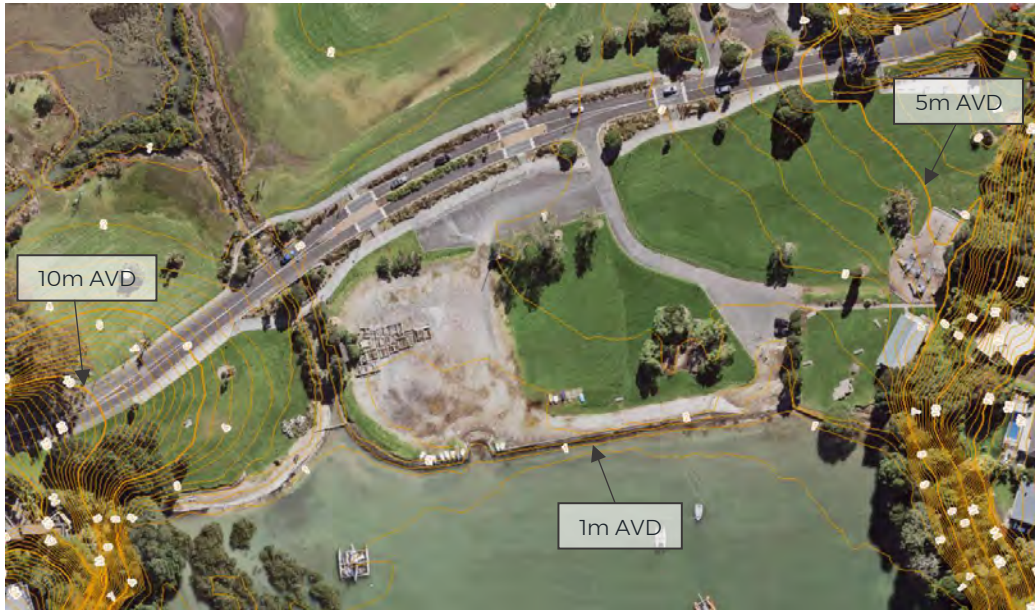
Figure 5 - Topography of Little Shoal Bay area

The Birkenhead Sea Scout Club house located is slightly raised within land that rises from approximately 2.75-4.5mAVD. The public playground situated to the north has an elevation of 3-5mAVD.

Maritime Terrace follows the contours of the surrounding open grassed / wetlands to the north and the hardstanding / public recreational facilities to the south (2.0 m AVD). The carriageway rises steadily with the terrain in the east at a gradient of 1:15 and 1:7 to the west.

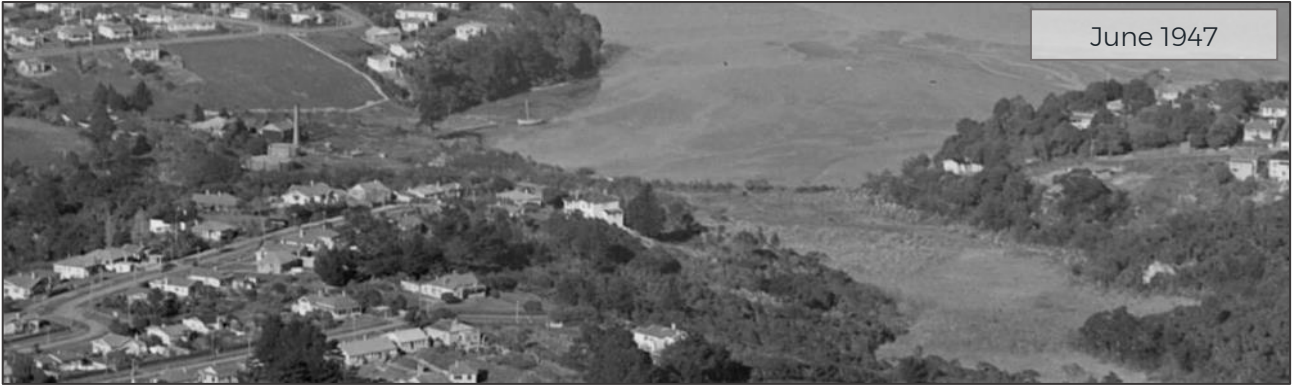
Figure 6. Aerial Photography of Little Shoal Bay taken in June 1947 (Retrieved from Morphem Environmental Ltd (2018); Original source: Whites Aviation, Alexander Turnbull Library Collection).

Little Shoal Bay is a highly modified coastline and the aerial photography below shows that the study area was once an open tidal inlet (Figure 6, Figure 7 & Figure 21). The land seaward of Maritime Terrace has been reclaimed and comprise of surplus material deposited from the Auckland Harbour Bridge development and from historic industrial activity (Morphum Environmental Ltd, 2018).

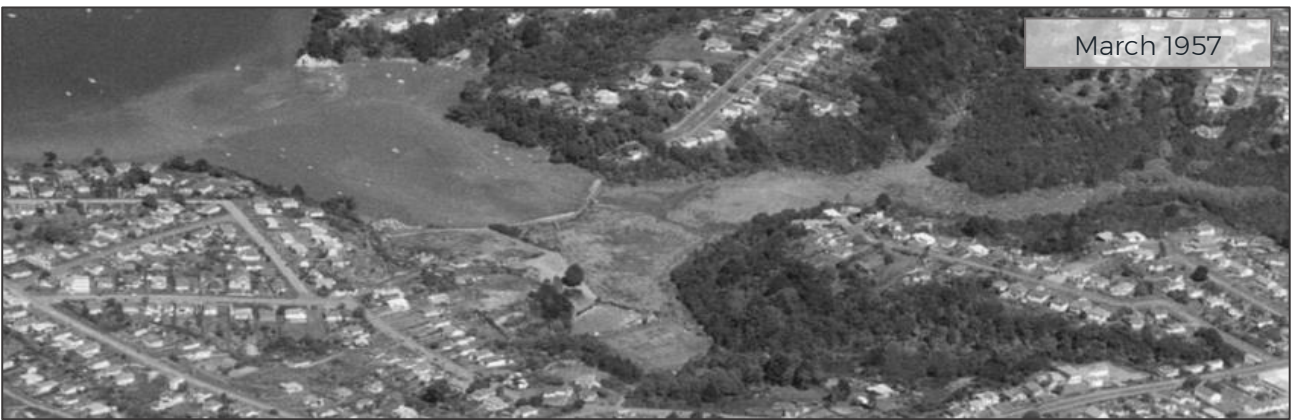
Figure 7. Aerial Photography of Little Shoal Bay taken in March 1957 (Retrieved from Morphem Environmental Ltd (2018); Original source: Whites Aviation, Alexander Turnbull Library Collection).

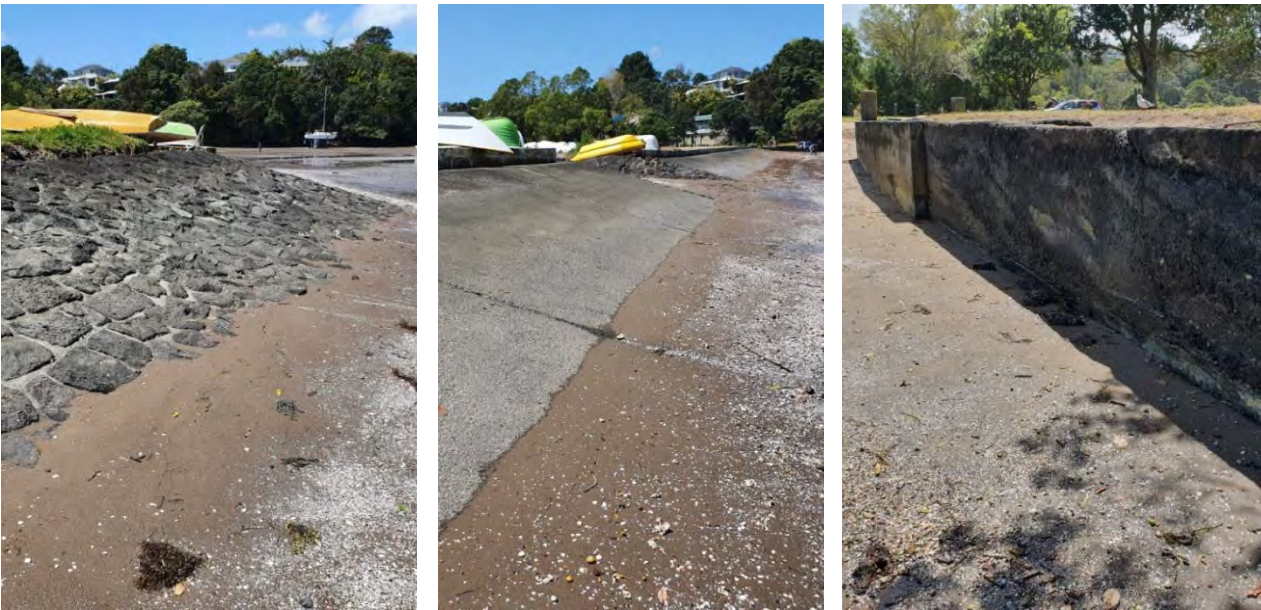
Figure 8. Little Shoal Bay hard coastal structures

The reclaimed land within the bay includes a seawalls of various construction techniques (including mass & reinforced concrete walls, grouted rock walls).

The seawalls are generally in fair to good condition with no obvious signs of displacement (cracking slumping, rotation, displaced blocks, etc.).

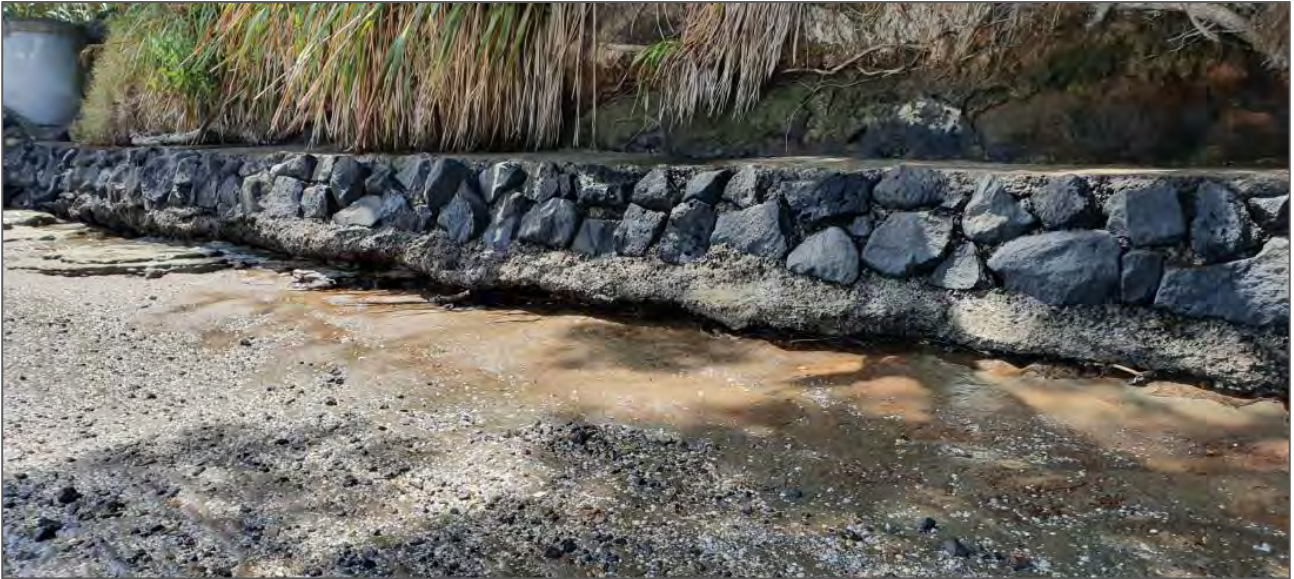
Figure 9. Undermining of gouted rock seawall on the eastern boundary of Little Shoal Bay.

Some areas of foreshore lowering/undermining were observed along the eastern side of the embayment (Figure 9). It is likely that the erosion/undermining at the toe of the seawall is due to wave action causing bed lowering.

We have not been able to obtain any long-term records to support analysis of changes in beach sand volumes over time. Analysis of historic aerial photographs suggests that the position of the high tide line has remained stable (influenced by the presence of the seawalls). By inspection of the seawall, it appears that the eastern side of the bay has lost a quantity of material since the construction of the seawall. A vertical lowering of the foreshore landward of the seawall is estimated in the order of 200-500mm at the toe (Figure 9).

The erosion at the toe of the existing seawall does not appear to have caused noticeable movement in the seawall (such movement might be evident by observation of rotation, slumping or cracking of the wall). This provides time for repairs or replacement options to be developed and implemented. Underpinning would work by filling the voids beneath the existing wall to provide a more stable foundation and fill the voids created by local foreshore lowering. Any replacement wall might include a deeper foundation to provide greater resilience against future foreshore lowering at the toe of the seawall.

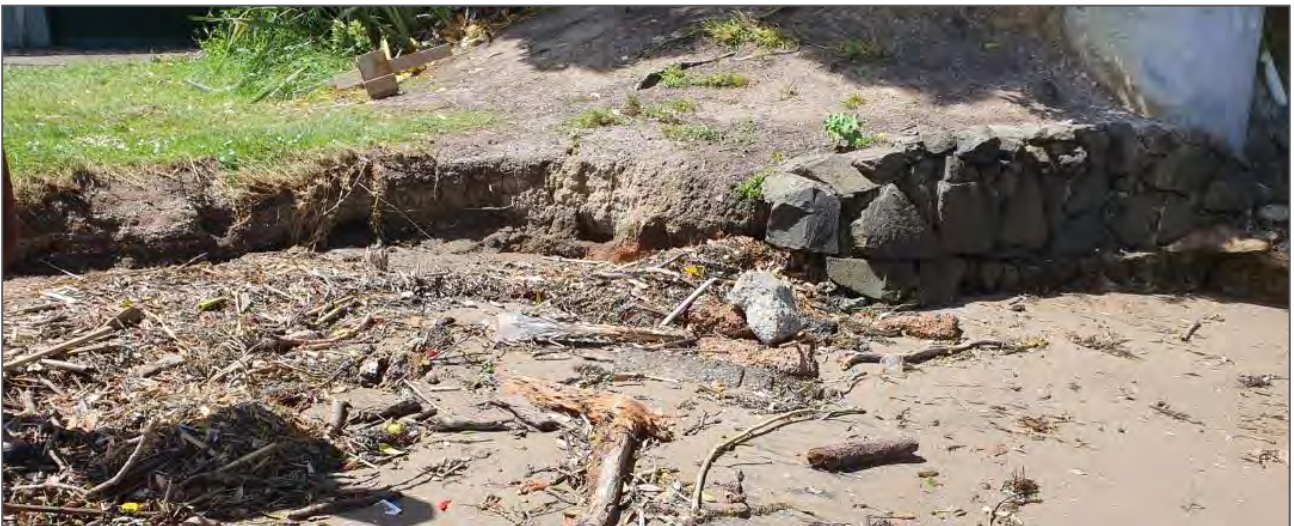
Figure 10. Localised erosion on the eastern side of bay

There are some areas of local erosion and outflanking (Figure 12) at the ends of the existing seawalls.

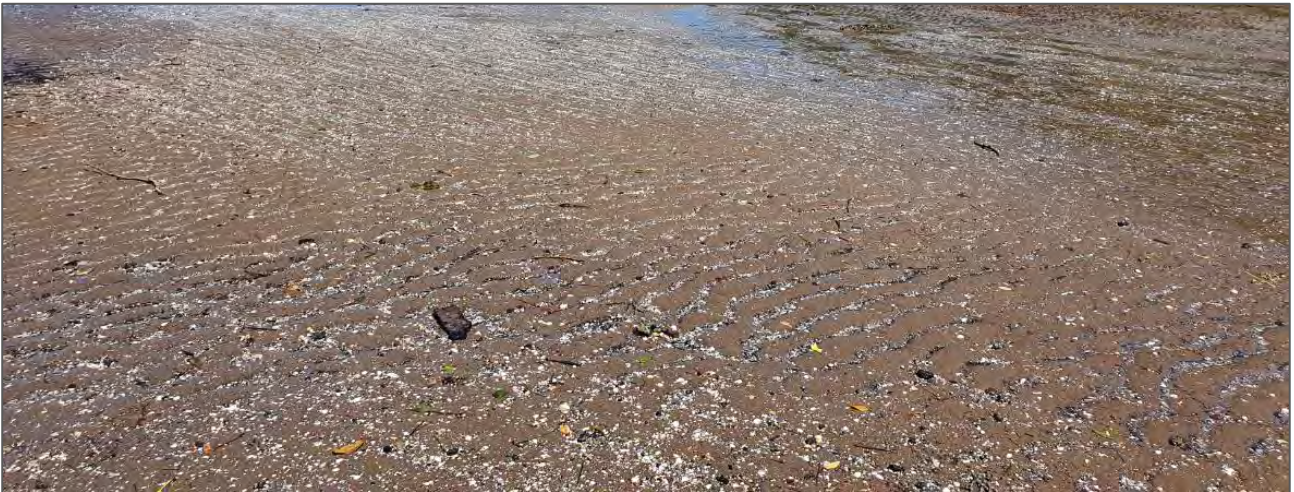
Figure 12. Small wave ripples on foreshore during low tide

In the intertidal area, small wave ripple bedforms were observed (Figure 12). An absence of current bedforms suggests that orbital wave velocities generally govern the movement of deposited bed sediment rather than tidal currents. Tidal currents alone are only strong enough to transport very fine material during flood tides, when current velocities are highest, with wave energy playing an important role in sediment transport and resulting morphology. However, there is potential for fine sediments re-suspended in the water column by high wind-wave action would be removed by an ebb tide.

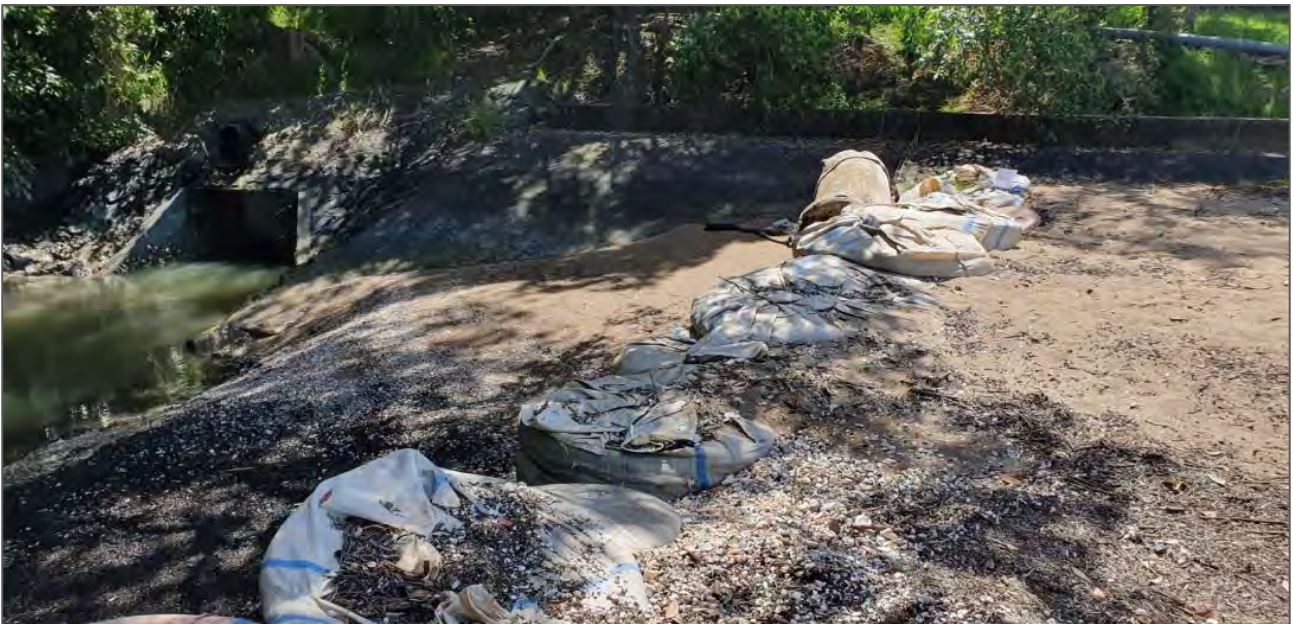
Figure 13. Construction of groyne structure to retain sediment on the eastern side, and the outlet located on the west of Little Shoal Bay

The construction of a single groyne has had limited effectiveness in forming an amenity beach at the scale of the wider bay. In order to develop such an amenity beach across a wider width of the bay, it is likely that many groyne structures would be required. Further nourishment is likely to be required to supplement the modest amounts of sediment supplied by natural processes. This is discussed further in the shoreline management options section of this report.

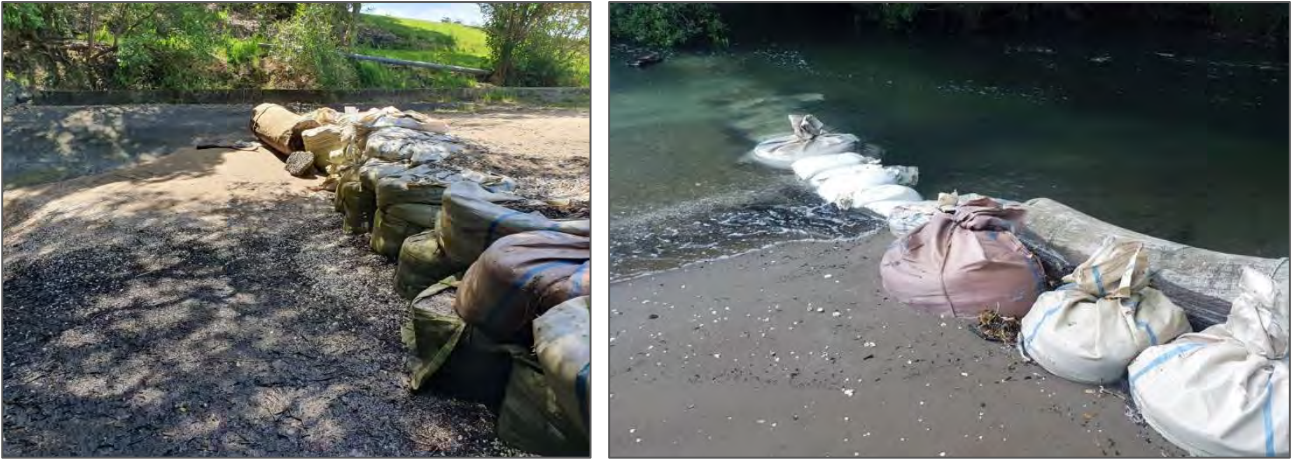
Figure 14. Groyne structure consisting of commercial sandbags with the aim of disrupting the cross-shore sediment movement (Left: Photograph from WSP site visit on the 30th of October 2019; Right: Stuff.co.nz (July 31st 2019).

The bags appear to be in fair condition with minor displacement and no obvious splitting or spilling. Such structures are typically temporary in nature with relatively short working lives. Deterioration and failure of the bags should be anticipated and bags removed (or replaced) before they fail to reduce the likelihood of release of plastic fibres into the environment.

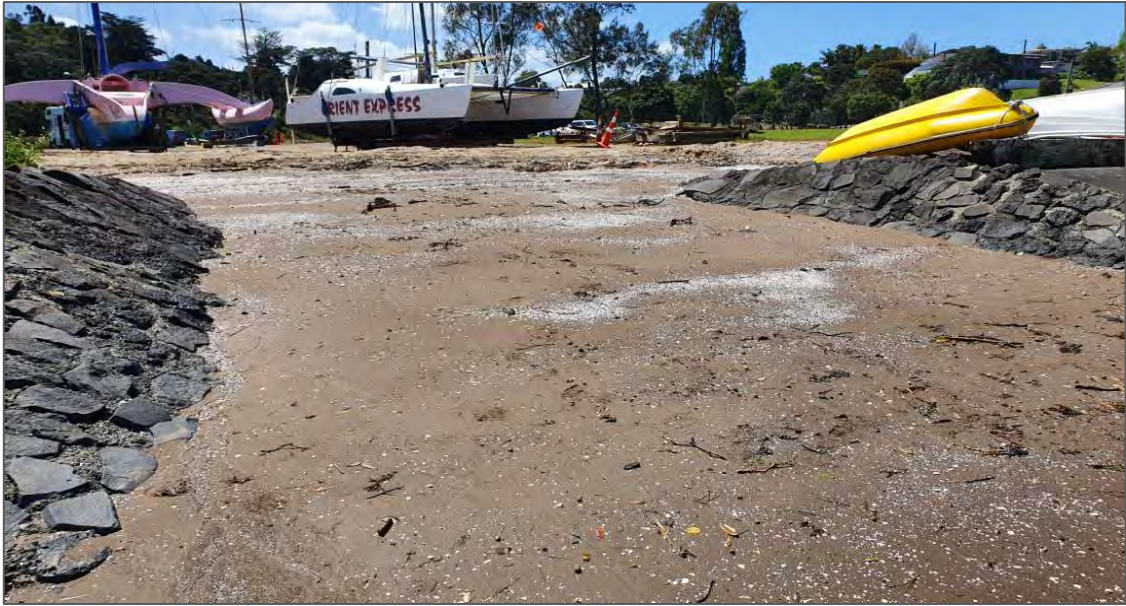
Figure 15. Boat ramp

The vertical/inclined seawall along Little Shoal Bay includes boat ramps (Figure 15, Figure 16). Both access points appear in fair to good condition with no obvious structural defects. Both access points are covered in sand and debris.

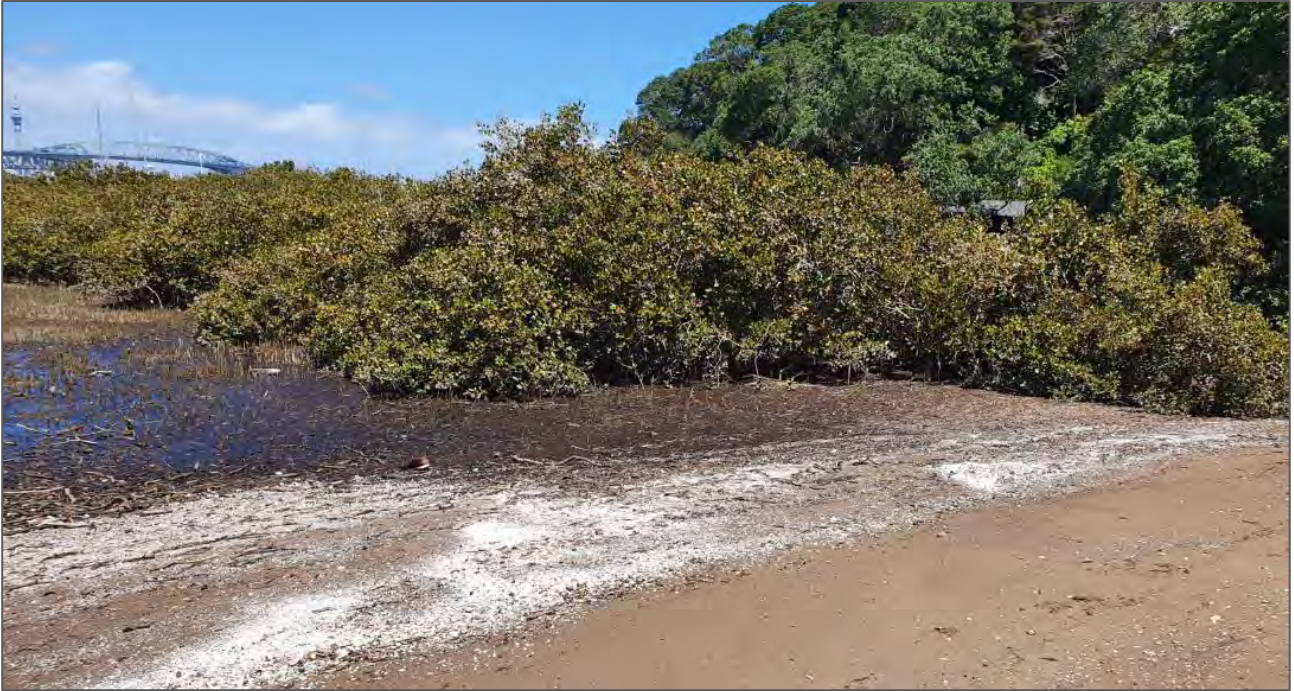
Figure 17. Mangroves at the western side of Little Shoal Bay

Mangroves are present on the western side of the embayment. Mangroves are known to trap sediment and accelerate land-building processes in tide-dominated coastal environments (Chaudhuri, et al., 2019). Figure 17 shows mangroves at the western edge of Little Shoal Bay which appear to have locally increased foreshore level by trapping sediment.

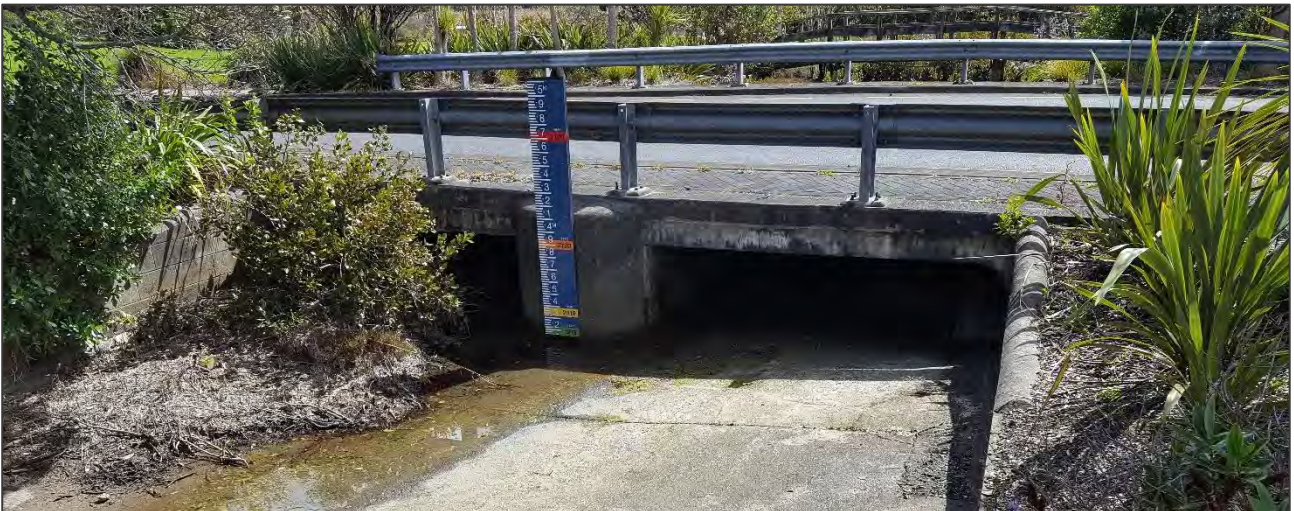
Figure 18. Box Culverts in Little Shoal Bay, showing the left box culvert partially blocked by debris and vegetation

Twin box culverts discharge stormwater at the western end of the bay. No internal inspection has been undertaken but the culverts appear to be in fair condition. One of the culverts is partially blocked by debris and vegetation which would reduce the capacity to discharge stormwater.

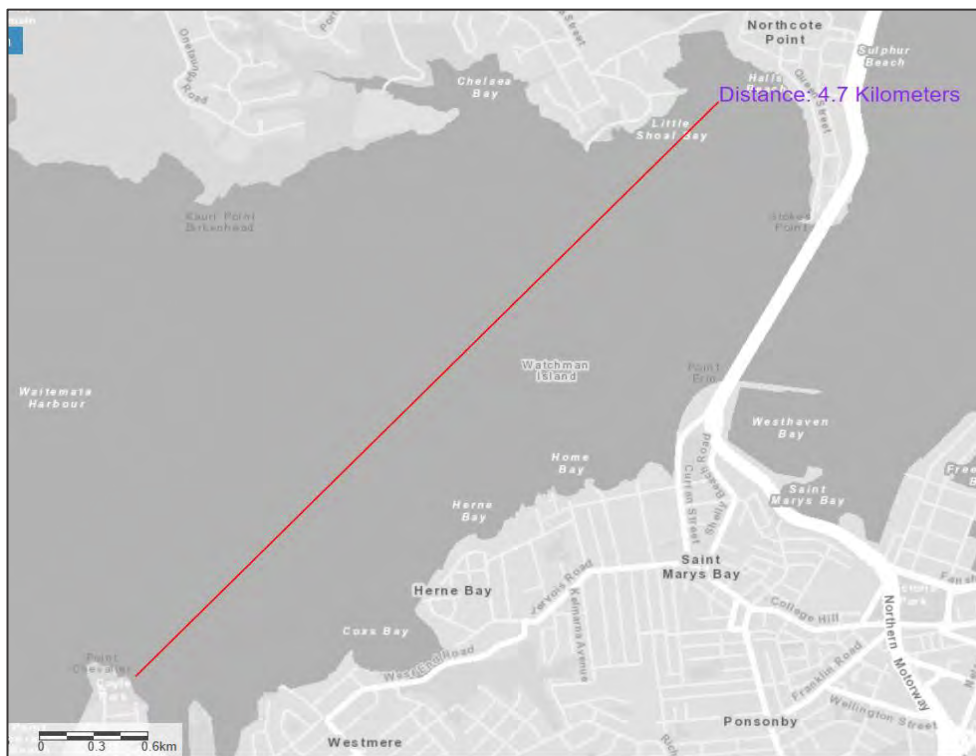
Figure 20. SW fetch distance from Little Shoal Bay (Measured with Auckland Council's Geomaps viewer: <https://geomapspublic.aucklandcouncil.govt.nz/viewer/index.html>)

Several methods were used to calculate the wind generated waves, these include fetch and wind speed forecasting curves from USACE (1984), BS (2000) and Groen & Dorrestein (1976). Given the information provided in Table 4 and Table 6, a maximum fetch available was measured as shown in Figure 20. It should be noted that the distance of the fetch, at high tide, is approximately 4.7 km from the southwest with wave energy considered to be interrupted by the presence of the Meola Reef

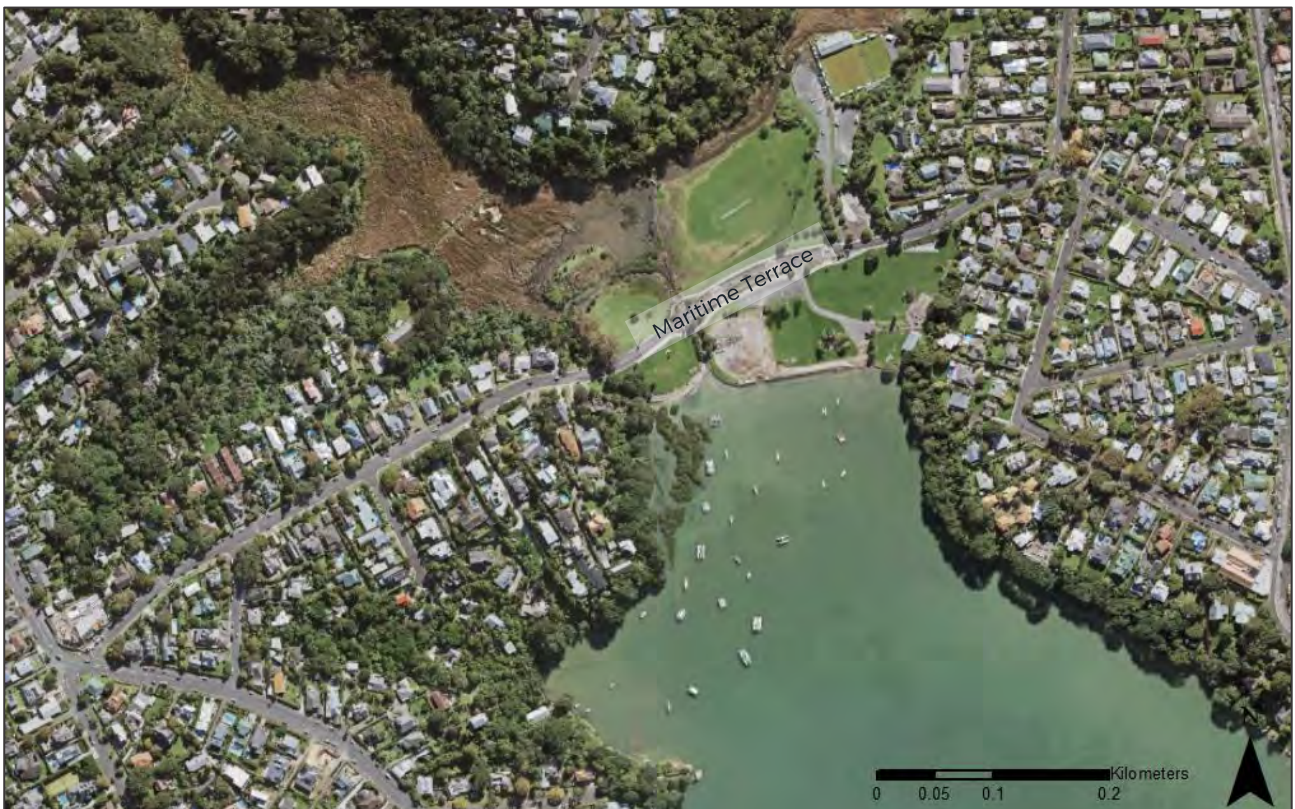
Figure 21. 2018 - Little Shoal Bay aerial image (Source: LINZ Data Service)

Aerial imagery (Figure 21) shows that Little Shoal Bay has no high-tide beach. During high tides the sea is in direct contact with the seawall and other hard-structures along the coastline.

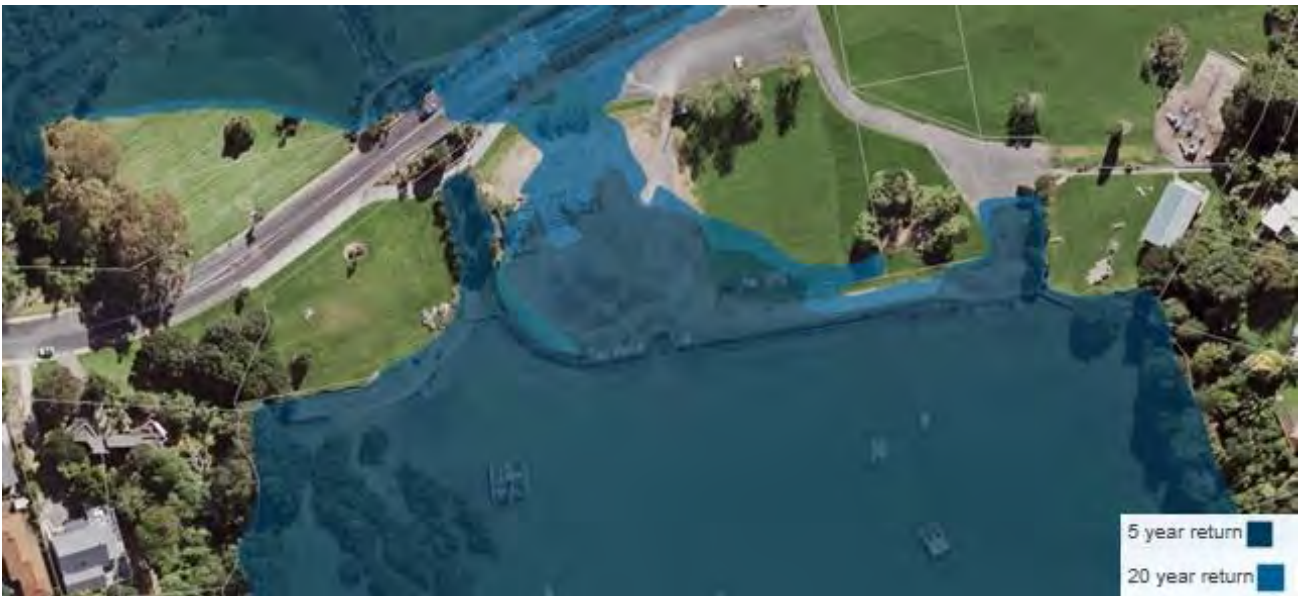
Figure 22. Coastal inundation for present day 5 and 20-year return period

Auckland Council and Auckland Emergency Management have a Hazard Viewer that allows users to visualise coastal inundation for different coastal inundation annual recurrence intervals (ARI) (Figure 22).

The area landward of Maritime Terrace is subject to regular inundation (with an annual exceedance probability of at least 20%). Such flooding of the boat hardstand and car park poses a risk to users of these areas and an environmental hazard should contaminants be released.

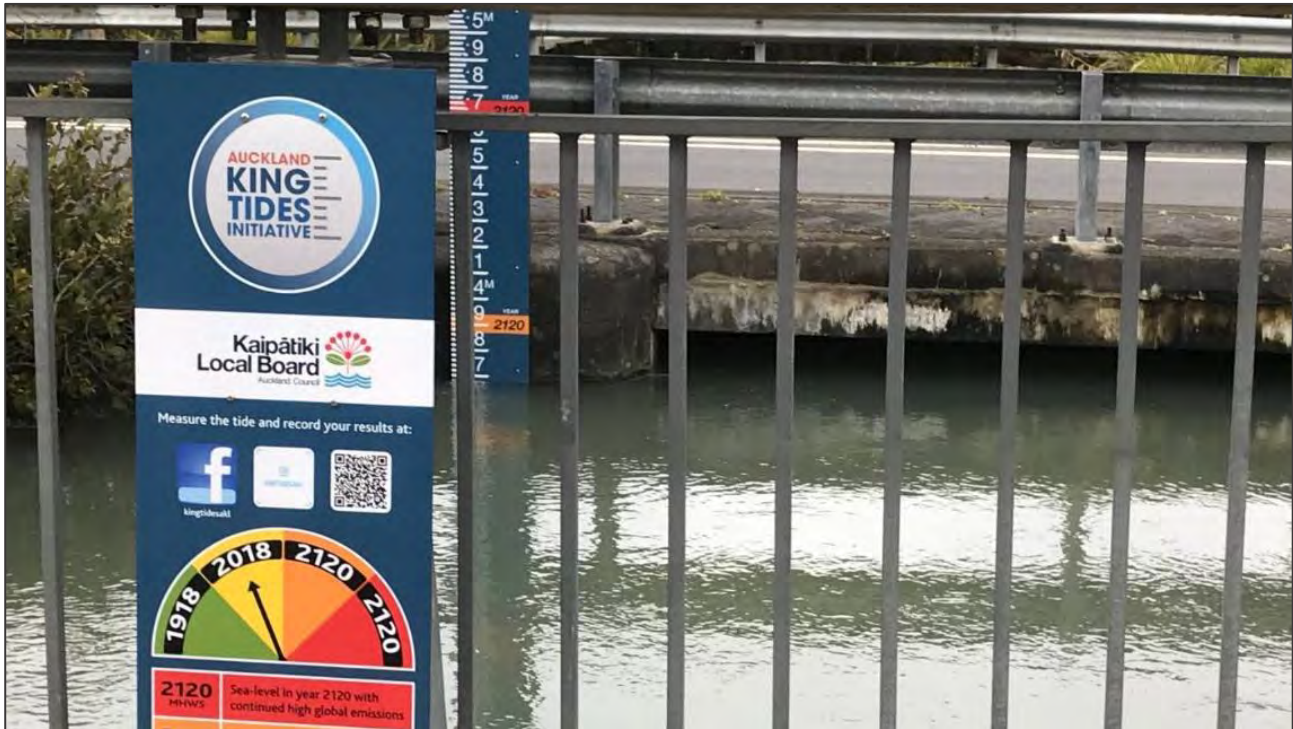
Figure 23 - Box Culverts in Little Shoal Bay, showing a mean high springs scenario almost reaching the orange line, which represents a water elevation prediction as best-case scenario of greenhouse gas emission until 2120 (Source: Stuff - Little Shoal Bay: Rising sea level)

Flooding is likely to increase in frequency and severity as result of climate change. Current guidance project 2120 mean sea level could be over 1m above those experienced today (MfE, 2017). Further increased frequency and severity of storms could lead to greater overtopping volumes and increased erosion rates.

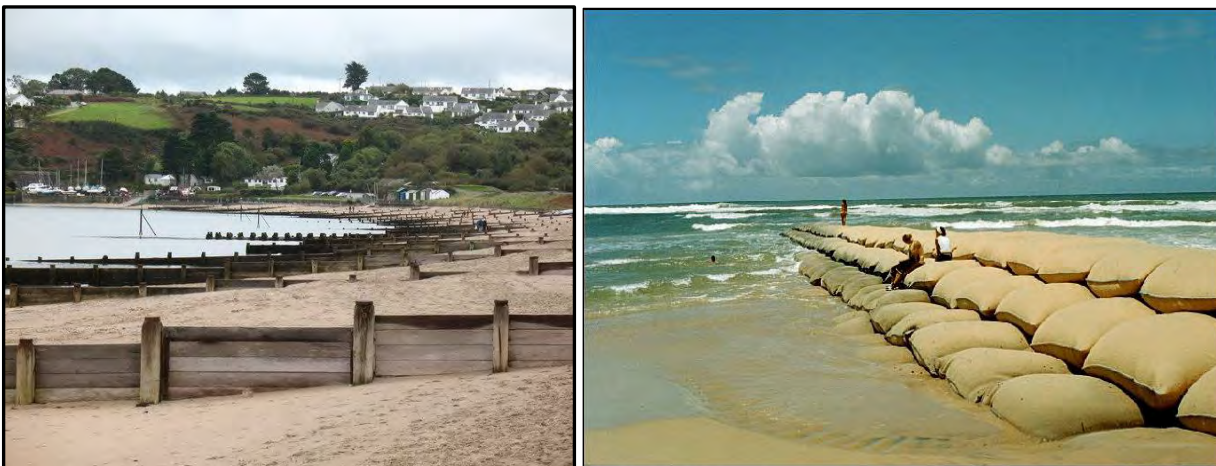
Figure 24. Timber and geotextile sand filled containers. (Photographs sourced from geograph.co.uk and researchgate.net respectively. Last accessed 22nd November 2019). Note these structures may not be appropriate for Little Shoal Bay

The introduction of groynes (timber, rock, concrete or submerged geotextile sand filled containers) perpendicular to the foreshore has the potential to trap sediment moving within the sediment cell. This material would accrete between the groynes and over time raise to form a natural barrier increasing the areas coastal structures.

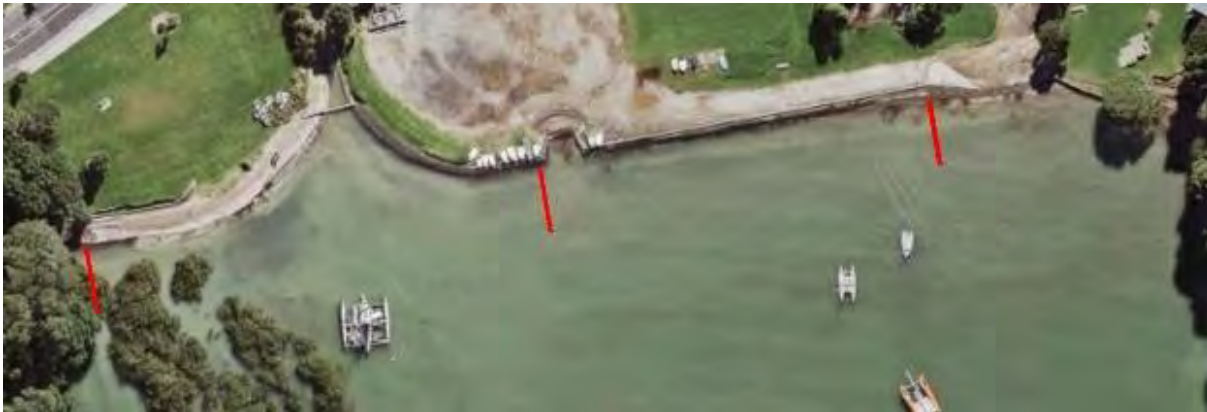
Figure 25 - Potential locations of groynes along foreshore perpendicular to existing coastal structures (Source: Auckland's Geomaps Interactive Viewer).

The coastal process review suggests that the existing temporary groyne has only accumulated modest quantities of material by natural processes. It is therefore likely that some additional nourishment will be required to supplement this material in order to create a useable amenity beach and to provide a seawall alternative (i.e. a gently sloping beach replacing/burying the existing seawall).

Further sediment movement and hydrodynamics investigations will be required to determine the required geometry and configuration of the groynes and to reduce the risk of impact on other regions of the Waitemata Harbour.

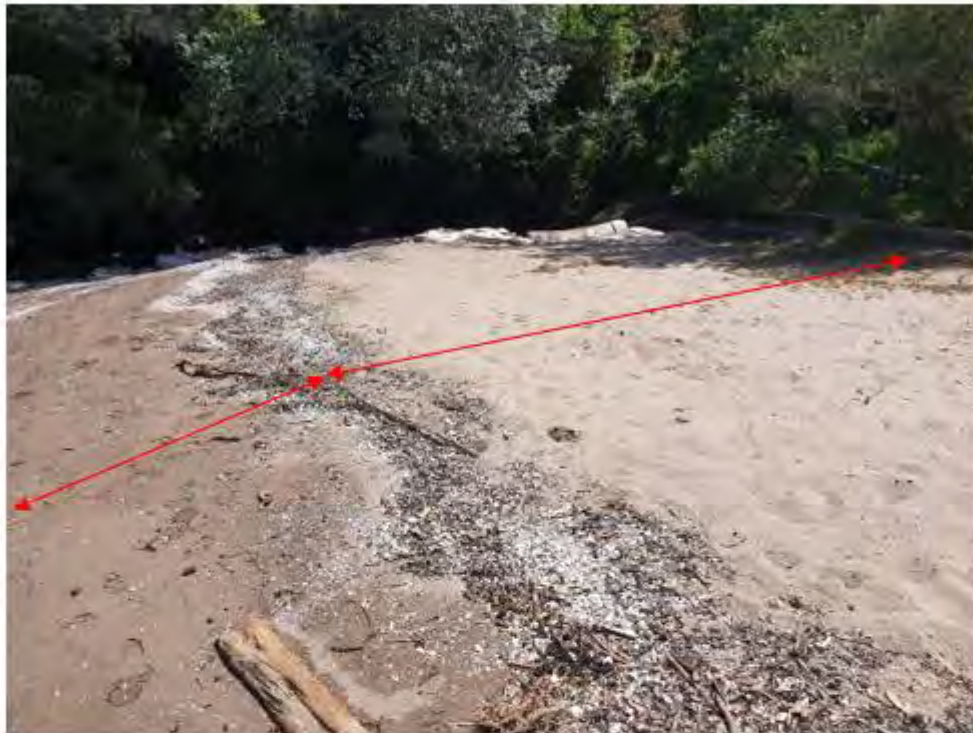
Figure 26- Initial concept for the design of an artificial beach or nourishment scheme

The design of an artificial beach or nourishment scheme needs more detailed consideration and better topographic information. Below we develop an initial concept based on the assumed topography and the evidence of the material retained by the ad-hoc groyne structure.

To create a beach the full 200m length of the little shoal bay frontage could therefore require some 3,000m³ of imported beach fill sand (assuming the above typical section). Information provided from Auckland Council relating to the Mairangi Bay scheme suggests costs of nourishment could be in the order of \$100/m³ suggesting a cost of \$300k for the nourishment component. The total cost of a nourishment scheme is likely to be significantly more when the cost of groyne construction, seawall demolition, accommodation/access works, design, consenting, risk contingency, etc. is added.

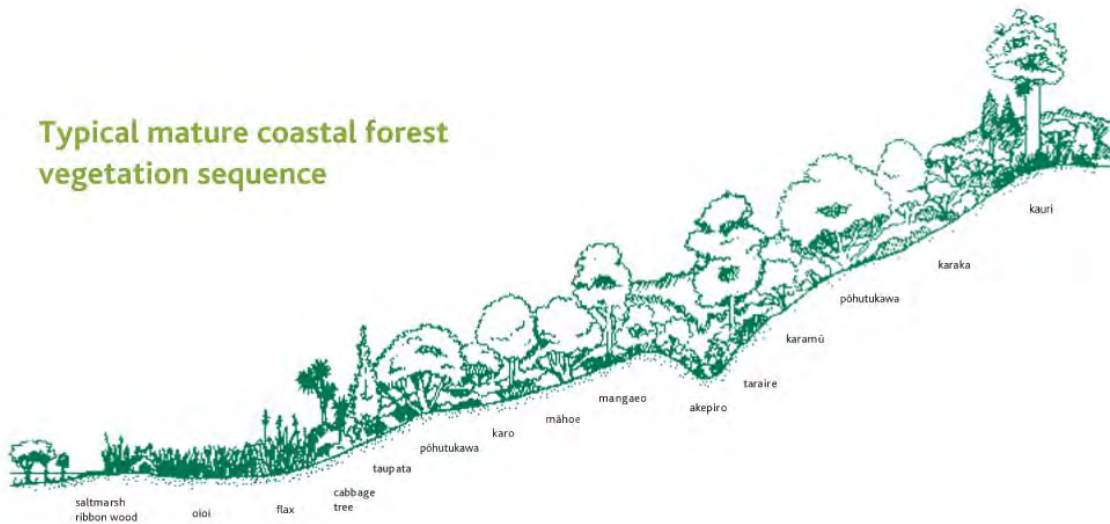
Figure 28 - Coastal planting from Auckland Council

The planted slope as a replacement for the seawall could comprise species similar to that recommended in Auckland Councils coastal planting guidance (Figure 28). Such a solution would require some land behind the existing seawall. Further maintenance of the slope and planting would be required after any storm damage.
